Tonal Noise in Gripen

Cockpit Noise and Vibration

Autumn Meeting SEES 2021-11-19

Saab Aeronautics (Faurecia Creo)

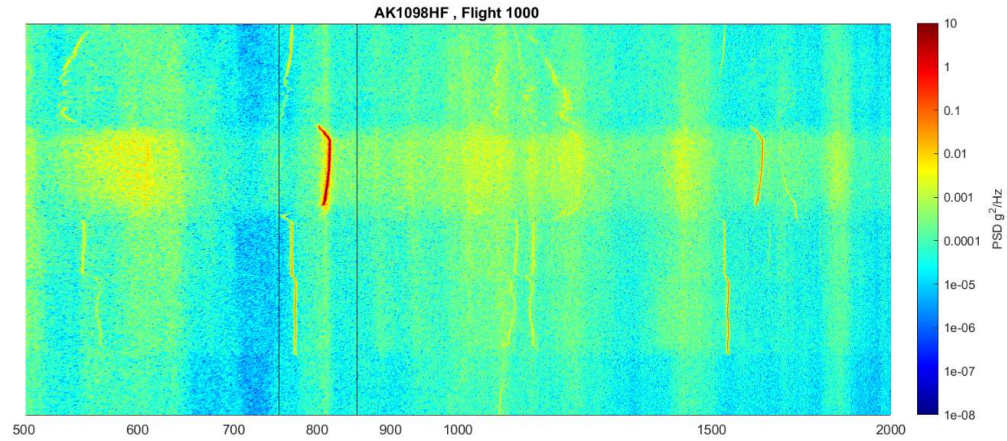
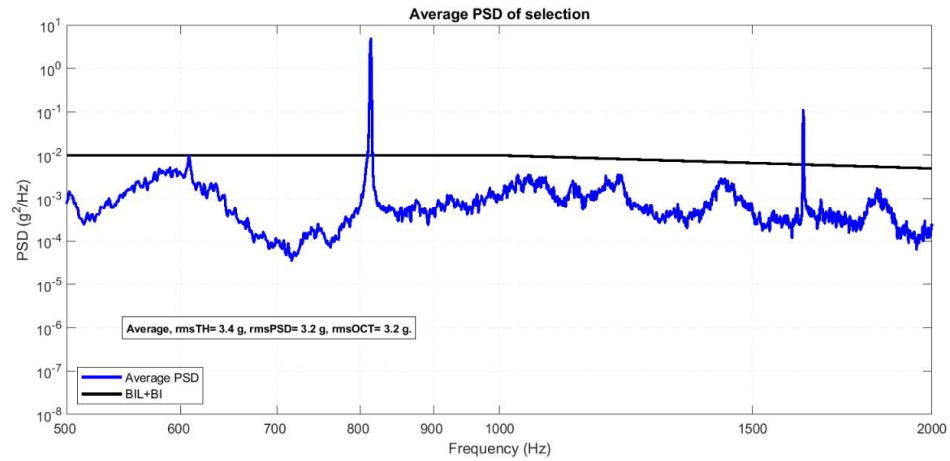
Vibration Baseline

- Vibration levels in 39.266 are higher than "normal"
 - levels are above qualification curve BI
 - Supersonic speeds at low altitudes
- At high altitudes the levels are below qualifications.
- Levels are still below qualification levels for Gunfire.
- Life is consumed at a higher rate than assumed when flying supersonic at low altitudes.

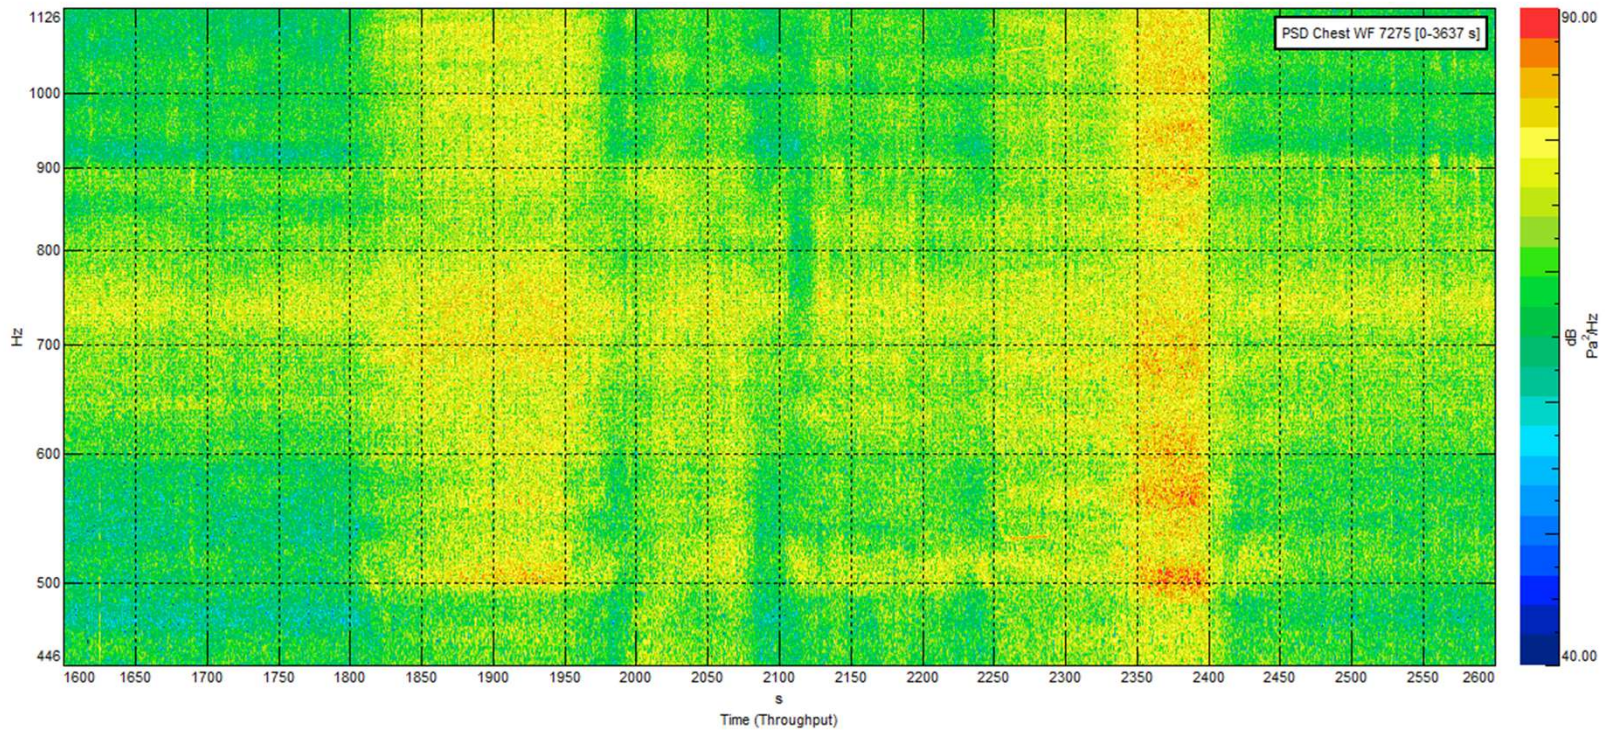
Chest sound taped intake

- No tonal sound in cockpit observed.
- Weak tonal vibration observed.
- Vibration levels are however below qualification for all speeds.

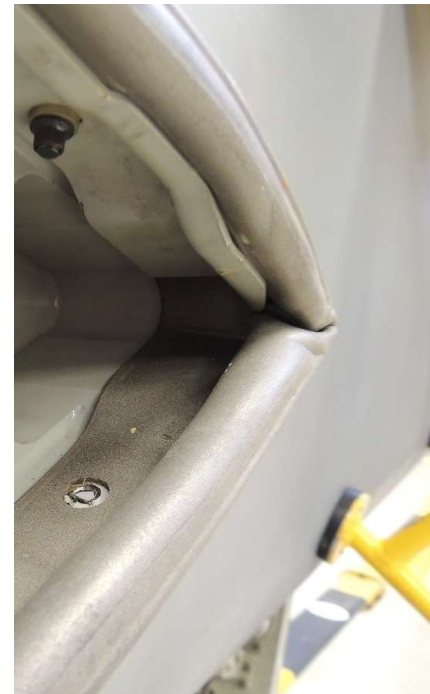
Old seal

- Tonal noise phenomena in 39.266 origin from bad seals in ECS air intakes
- Generates high vibration levels at high speeds
- The data show that there is no immediate risk
- It is recommended to avoid flying with tonal noise at these conditions for long periods.
- Aircraft with tonal noise shall be fitted with new seals

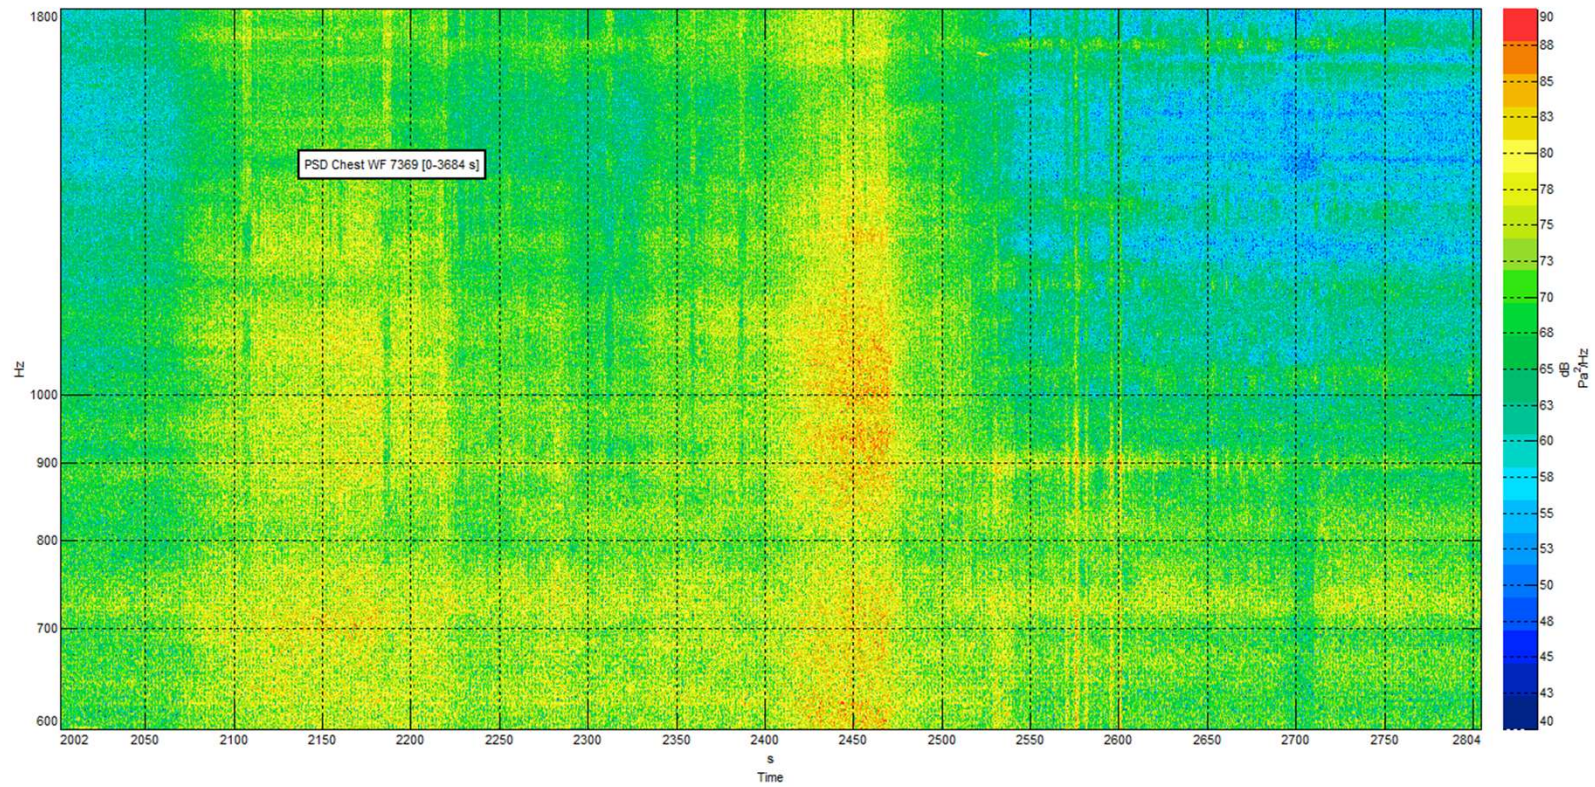
Chest sound new seal with support

- No tonal sound in cockpit observed.
- No tonal vibration observed at equipment.
- Vibration levels are below qualification for all speeds.
