Tonal Noise in Gripen

Cockpit Noise and Vibration

Autumn Meeting SEES 2021-11-19

Saab Aeronautics (Faurecia Creo)

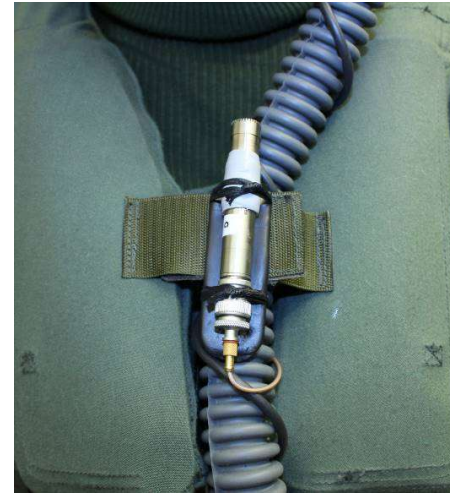
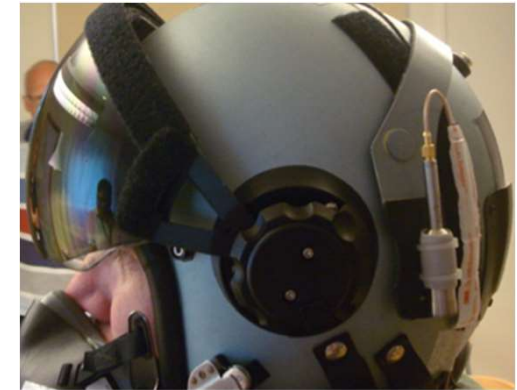
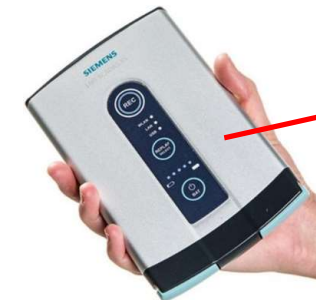
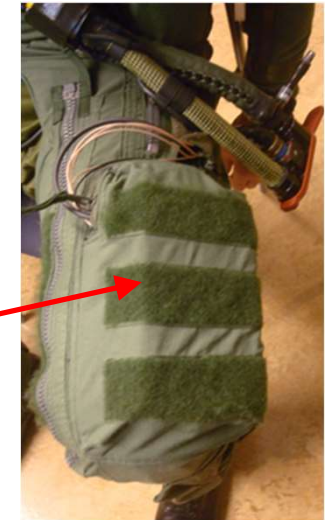
- Two microphones
 - Pilot chest
 - Pilot helmet
- Siemens LMS SCADAS-XS recording unit
 - Placed in thigh pocket (see picture)
 - Weight ~500 g

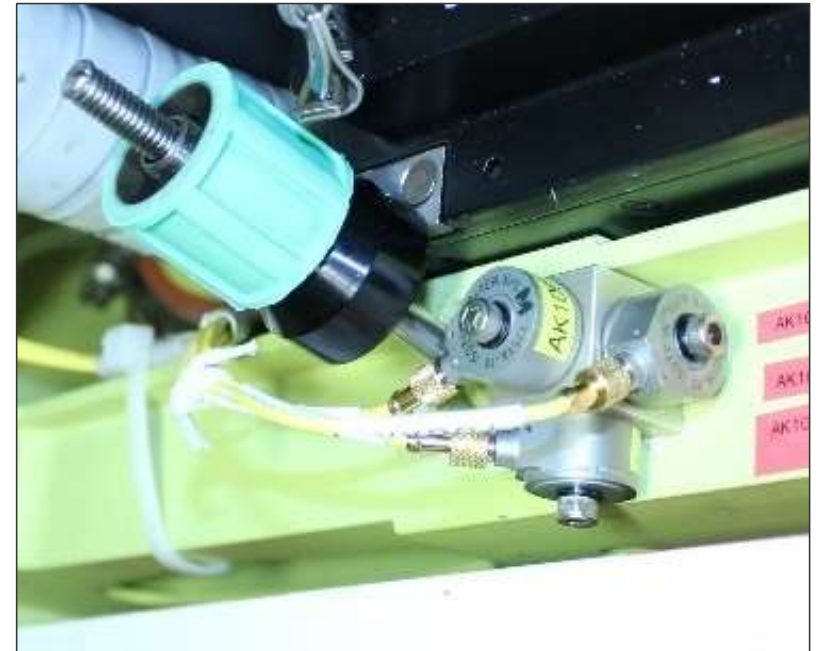
- Accelerometers at equipment attachment
- Data recorded with an ACRA system from Curtiss-Wright

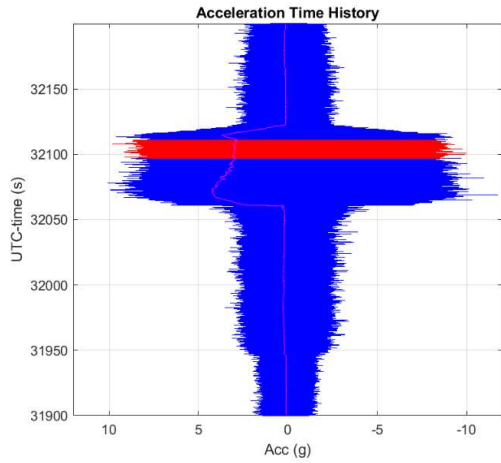
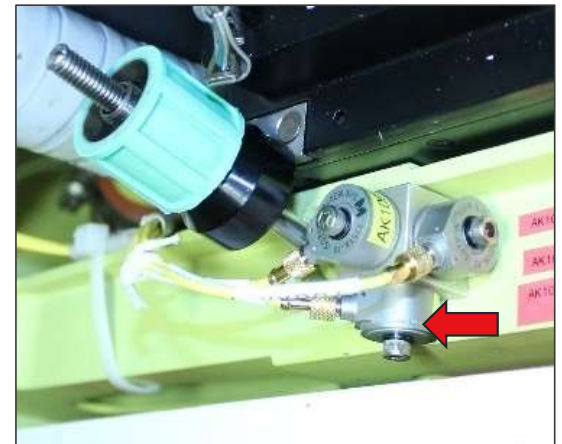
Vibration Baseline

- Tonal noise phenomena in 39.266 origin from bad seals in ECS air intakes
- Generates high vibration levels at high speeds
- The data show that there is no immediate risk
- It is recommended to avoid flying with tonal noise at these conditions for long periods.
- Aircraft with tonal noise shall be fitted with new seals
